Property Inspection Service

PROFESSIONAL BUILDING INSPECTION

Single Family Home

10234 Anywhere Avenue, Great City, CA

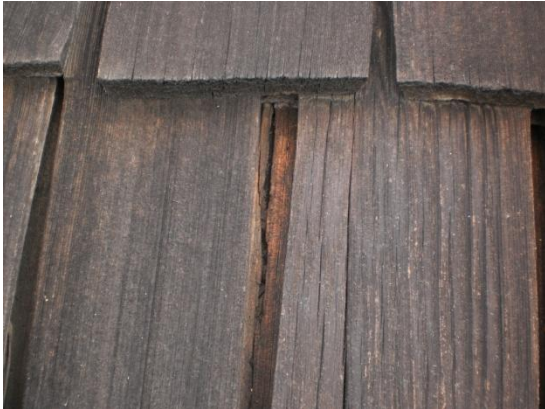
The wood shake roof coverings for the house and detached garage have evidence that suggests **CORRECTIVE WORK SHOULD BE PERFORMED** at this time because there is exposed underlayment at the south sides of the detached garage and house. It is recommended that a competent roofing contractor be consulted for recommendations and corrective work. SEE PHOTO SUMMARY

There is exposed underlayment at the south side of the house.

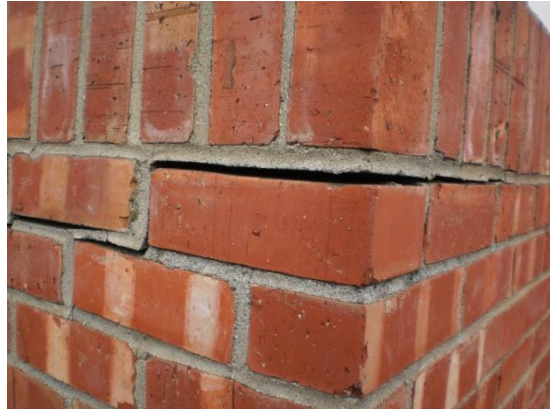
A. There is evidence of large cracks at the top of the chimney. SEE PHOTO SUMMARY
It is recommended that a competent masonry contractor be consulted for recommendations and corrective work.

There is evidence of large cracks at the top of the chimney.

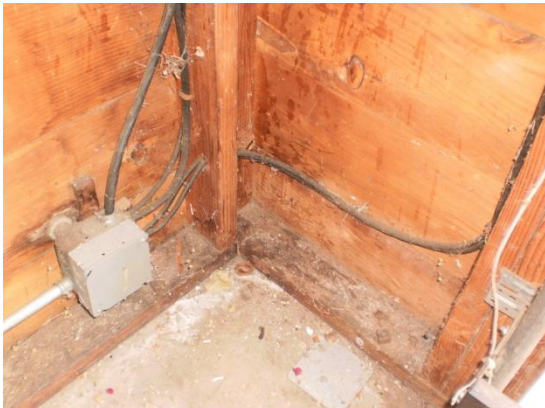
- D. There is electrical circuit wiring that is not considered adequately protected in the detached garage at the west wall and in the workshop. The code requires all wiring less than seven feet above the floor, or in an area where it could be damaged, be mechanically protected. This is typically done by using metal conduit or by installing the wire behind a sheetrock wall surface. SEE PHOTO SUMMARY
- E. There are multiple circuits wired to single breakers at the sub panel.
- F. There is an improper connection of circuit wires to the main lugs in the main panel. SEE PHOTO SUMMARY
- G. The exterior duplex outlet at the rear of the house is not provided with a weatherproof cover.

There is electrical circuit wiring that is not considered adequately protected in the detached garage at the west wall.

It is recommended that a competent electrical contractor be consulted for recommendations and corrective work. Please be advised that many non-code complying electrical conditions may be considered a potential fire hazard and/or threat to health and safety.

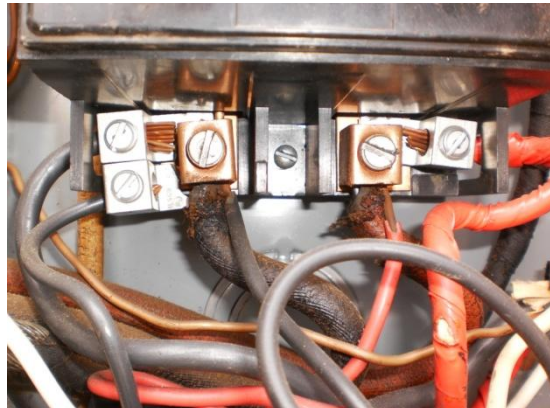
There is an improper connection of circuit wires to the main lugs in the main panel.

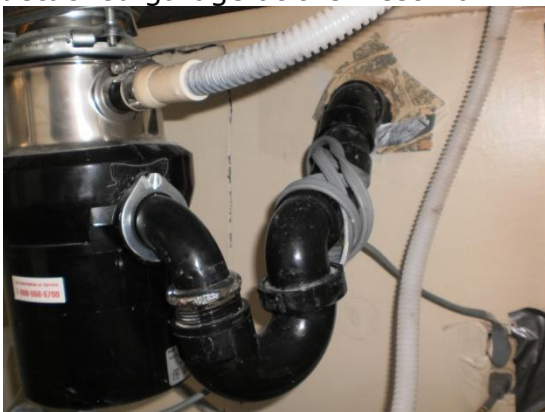
- A. The hallway bathroom tub drains slowly indicating it may require drain trap cleaning.
- B. A drain stopper is not provided to serve the hallway bathroom tub.
- C. There is evidence of present leakage in the crawl space below the master bathroom shower.
- D. The drainage piping in the crawl space below the master bathroom is an improper slope.
- E. The drainage piping in the cabinet below the kitchen sink is an improper design. SEE PHOTO SUMMARY

The drainage piping in the cabinet below the kitchen sink is an improper design.

It is recommended that a competent plumbing contractor be consulted for recommendations and corrective work.

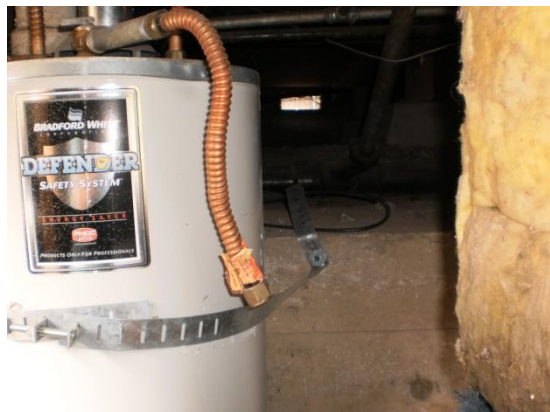
- A. The discharge piping for the temperature/pressure relief valve terminates in the basement. The code requires that this safety valve have a rigid piped system to deliver the discharged water to a safe location to avoid accidental personal injury. SEE PHOTO SUMMARY

The discharge piping for the temperature/pressure relief valve terminates in the basement.

It is recommended that a competent plumbing contractor be consulted for recommendations and corrective work.

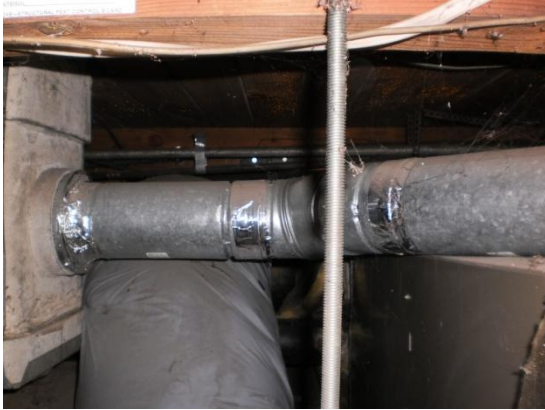
- A. The flue serving the heating unit is improperly sloped in the basement. SEE PHOTO SUMMARY

The flue serving the heating unit is improperly sloped in the basement.

It is recommended that a competent heating contractor be consulted for recommendations and corrective work.
