Property Inspection Report

Property Address:	31415 Da Vinci Lane, San Jose, CA
Type:	Single Family Residence
Inspection date:	April 13, 2017
Inspected for Client:	Jamie Oliver
RE Agent:	Stephen William Hawking
Company:	Forever Realty
Address/City:	16180 Golden Palace Drive, Cupertino, CA
Inspected by:	Chris Kremer, Alex Abreu, or Sean Johnson

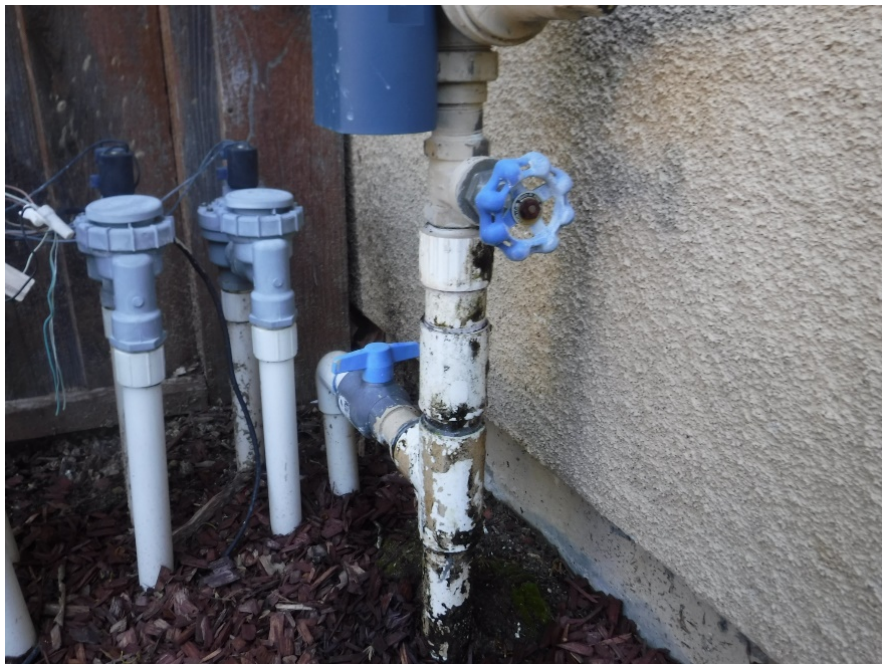
A. There is evidence of present leakage at the water main. SEE PHOTO
It is recommended that a competent plumbing contractor be consulted for recommendations and corrective work.

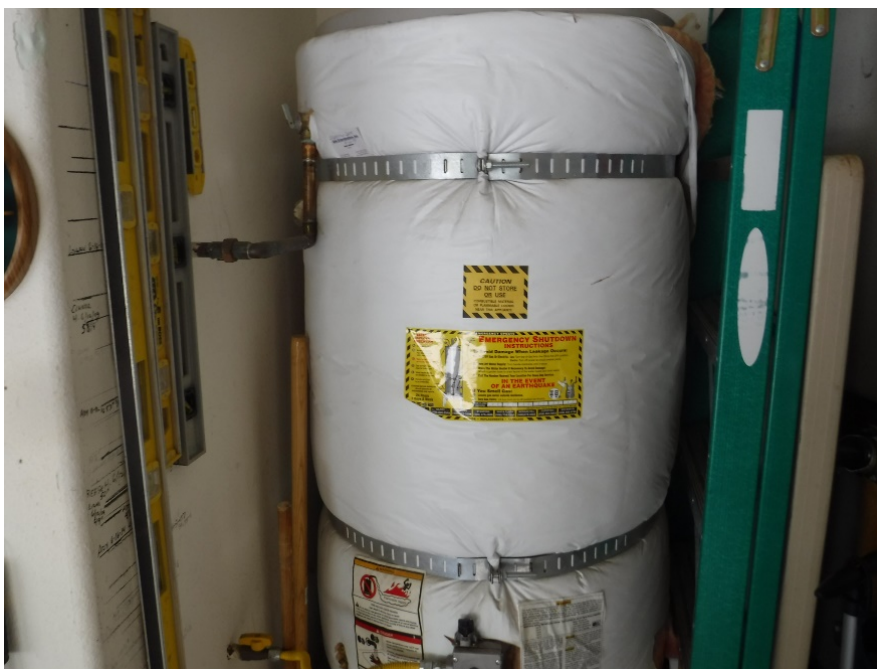
- A. This water heater is strapped by the most popular method, however it is not in compliance with the methods suggested by the Division of the State Architect because it is missing the third strap. SEE PHOTO

It is recommended that a competent plumbing contractor be consulted for recommendations and corrective work.

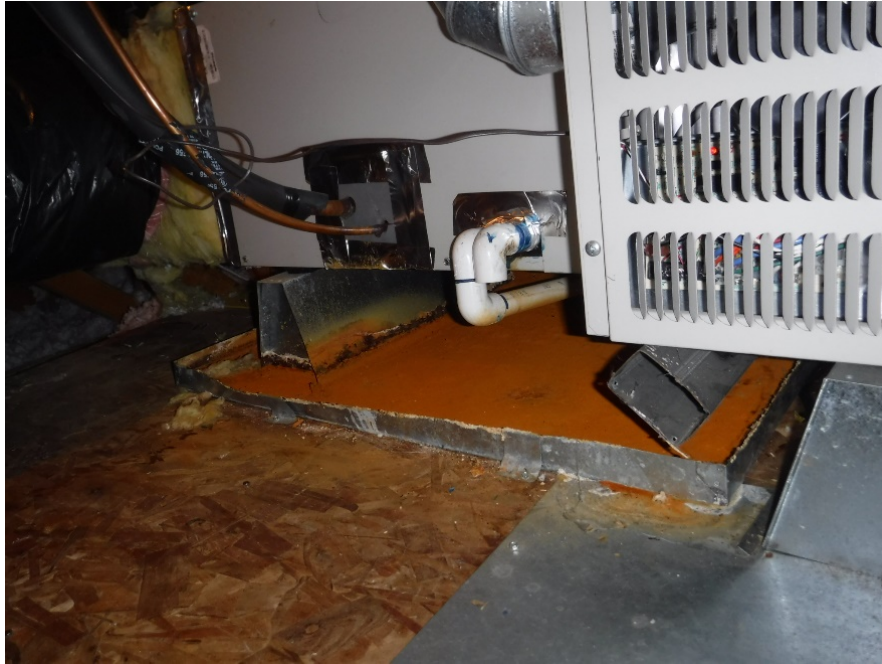
Evidence of moisture was noted at the secondary drain pans indicating possible clogged or improperly configured primary drain lines at each unit. It is suggested that the condition be corrected. SEE PHOTO
